**ADDENDUM #3 – OCTOBER 14, 2025**

RE: **EASTSIDE FIRE STATION**  
Seismic Grant Upgrade REBID  
**Project #22.22.2**

Re: AE 25052699 CBF D Eastside Station 3 Hazardous Materials Inspection Addendum

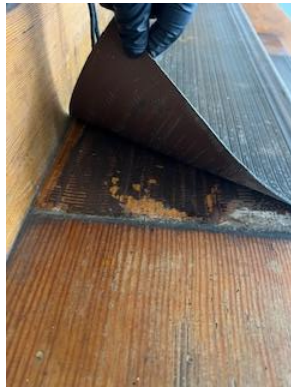
Stair tread

| Sample # | Description | Condition | ACM % | Friable/NON |
|---|---|---|---|---|
| STM 3 | Stair Tread Mastic | | | |
| | - Brown Mastic | Good | Non-detect | N/A |

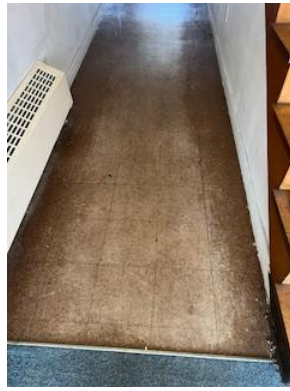
Hall tile flooring

| Sample # | Description | Condition | ACM % | Friable/NON |
|---|---|---|---|---|
| FT 2 | Floor Tile – Hall w/Mastic Approx. 252 | | | |
| | - Brown Floor Tile | Good | 4% Chrysotile | Friable |

The building is an older structure with various upgrades over the years all suspect asbestos containing materials discovered were sampled, the materials positive for asbestos are floor tiles, and original window putty. One sample of floor mastic has trace Asbestos (<1%), it is recommended that all mastic removed with the floor tiles should be treated as ACM unless tested again to verify it is not ACM.

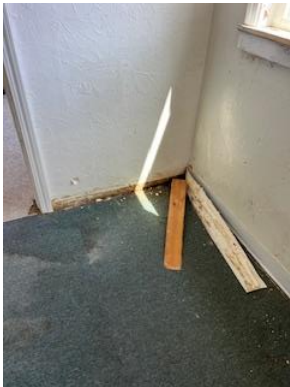
Front office toeboard

| Sample # | Description | Condition | ACM % | Friable/NON |
|---|---|---|---|---|
| TBM 7 | Toeboard Mastic – Main Office | | | |
| | - Brown Mastic | Good | Non-detect | N/A |

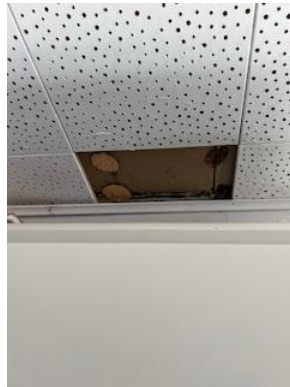
Front office ceiling tile

| CT 10 | Ceiling Tile w/Mastic – Main Office | | | |
| | - Brown Tile | Good | Non-detect | N/A |
| | - Brown Mastic | Good | Non-detect | N/A |

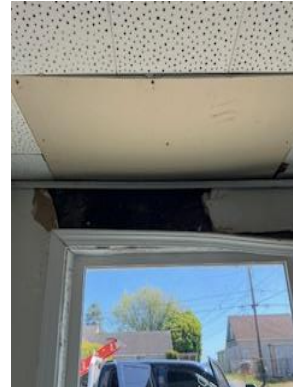
Front office wall

| Sample # | Description | Condition | ACM % | Friable/NON |
|---|---|---|---|---|
| WP 9 | Wall Plaster on Sheetrock – Main Office | | | |
| | - White Plaster | Good | Non-detect | N/A |

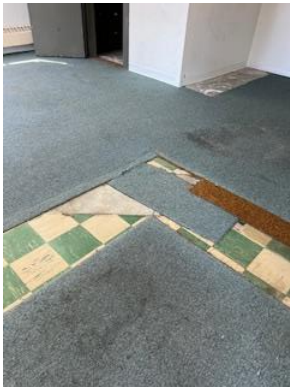
Front office flooring

| Sample # | Description | Condition | ACM % | Friable/NON |
|---|---|---|---|---|
| FT 4 | Main Office Floor Tile – Green w/Mastic | Approx. 396 | | |
| | - Green Floor Tile | Good | 4% Chrysotile | Friable |
| | - Cream Floor Tile | Good | 4% Chrysotile | Friable |
| | - Black Mastic | Good | < 1% Chrysotile | Non-friable |

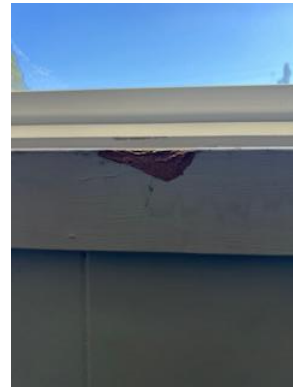
upstairs window sill

| WP 16 | Window Putty – West Windows    1 Window = Approx. 10 LF | | | |
| | - Grey Putty | Good | 2% Chrysotile | Friable |

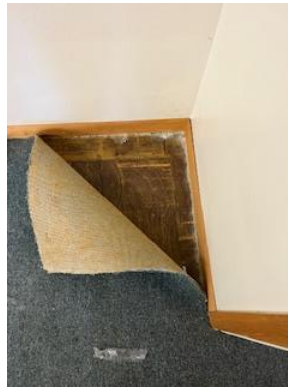
upstairs flooring

| FT 11 | Floor Tile, Brown – Under Carpet    Approx. 890 | | | |
| | - Brown Floor Tile | Good | 3% Chrysotile | Friable |
