**ADDENDUM #3 – OCTOBER 14, 2025**

RE: **EASTSIDE FIRE STATION**  
Seismic Grant Upgrade REBID  
**Project #22.22.2**

Re: AE 25052699 CBF D Eastside Station 3 Hazardous Materials Inspection Addendum

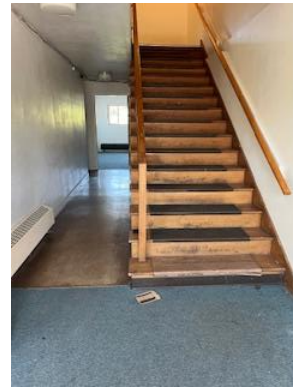
Hall & stairs

| Sample # | Description | Condition | ACM % | Friable/NON |
|---|---|---|---|---|
| FT 2 | Floor Tile – Hall w/Mastic Approx. 252 | | | |
| | - Brown Floor Tile | Good | 4% Chrysotile | Friable |

The building is an older structure with various upgrades over the years all suspect asbestos containing materials discovered were sampled, the materials positive for asbestos are floor tiles, and original window putty. One sample of floor mastic has trace Asbestos (<1%), it is recommended that all mastic removed with the floor tiles should be treated as ACM unless tested again to verify it is not ACM.

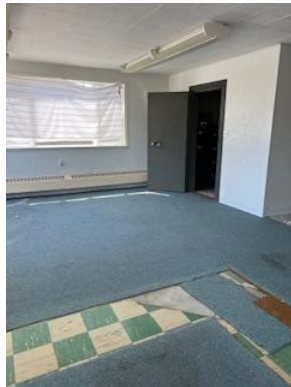
front office

| Sample # | Description | Condition | ACM % | Friable/NON |
|---|---|---|---|---|
| FT 4 | Main Office Floor Tile – Green w/Mastic | Approx. 396 | | |
| | - Green Floor Tile | Good | 4% Chrysotile | Friable |
| FT 5 | Main Office Floor Tile – Cream w/Mastic | See above sample 4 for SF | | |
| | - Cream Floor Tile | Good | 4% Chrysotile | Friable |
| | - Black Mastic | Good | < 1% Chrysotile | Non-friable |
